Earthquake resistant earthen construction

Reference bibliography

CRATerre-EAG

Novembre 2004

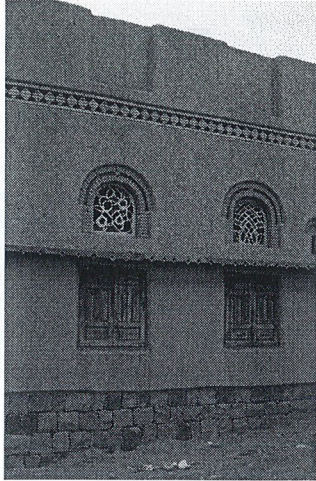
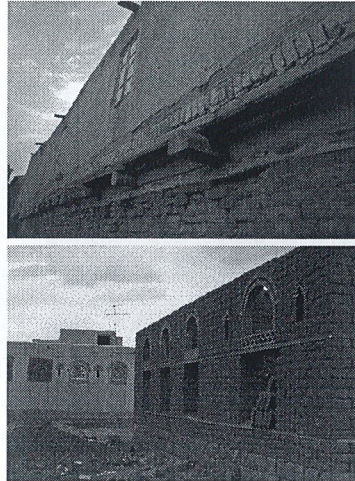
In Uzbekistan, tradition and actuality

Wooden ring beams are cleverly positioned and flexible (ductility, horizontal motion). The position of arched bays is well-balanced and does not concentrate the voids

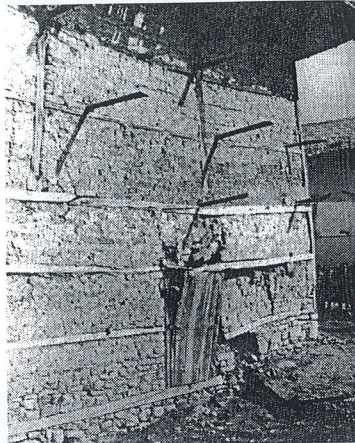
Vernacular adobe construction in Turkey

Successive and close horizontal wooden ring beams, vertical reinforcements, are properly positionned within the wall

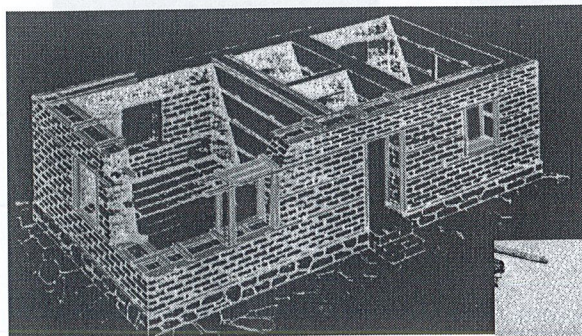
Implementing traditional solutions in seismic areas

This adobe house has
resisted to the seism of
Irpinia (1981)

Wooden ring beams are regularly
distributed within the thickness of the walls
The wooden frames of the bays are
reinforced and connected to the wooden
ring beams.

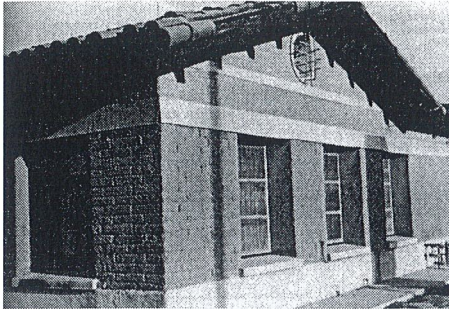
This adobe structure has been built in 1935. Appropriate design and good maintenance

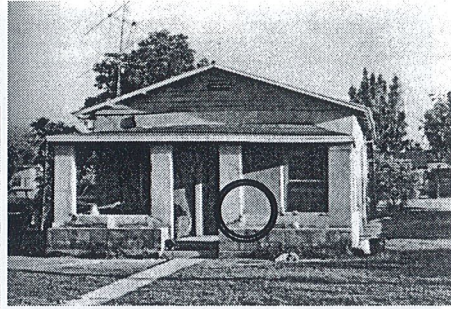
This adobe structure has been retrofitted after a seism with wooden ring beams and cables

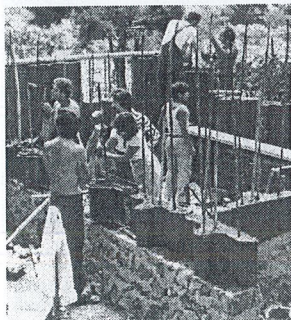
Building elements in rammed earth, stables and 80 cm thick, with integrated buttresses

These elements in rammed earth are independent
Vertical reinforcements are made of bamboo sticks that are connected by wooden ring beams

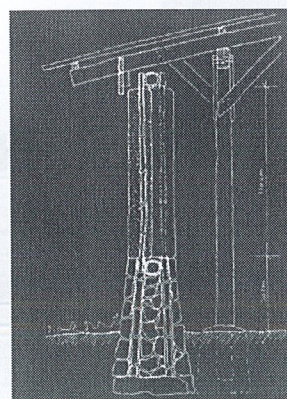
Roofing is independent from the walls

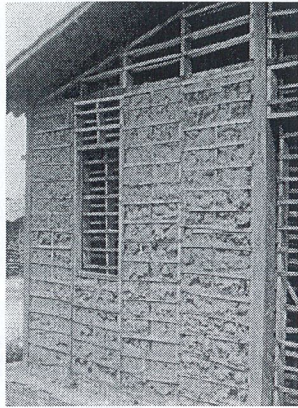
Walling in prefabricated elements
(fast building process)

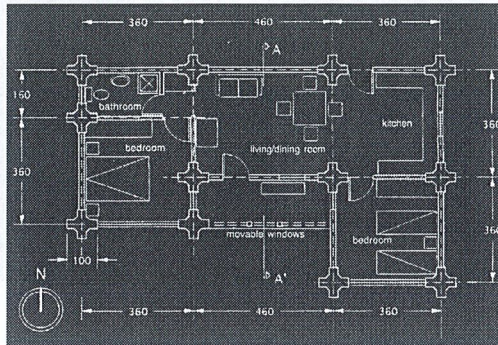
Rammed earth pillars are supporting the roof. In between these pillars partition walls are in wooden frames infilled with daub (earth and straw)

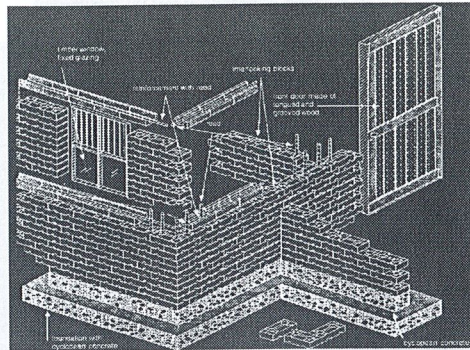
- Blocks are laid without mortar (dry masonry) improving the wall flexibility

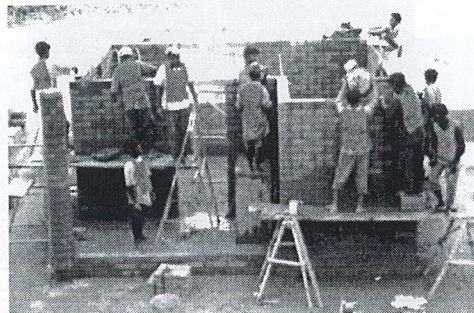
Vertical and horizontal reinforcements tightly anchored

Wide range of CEB interlocking blocks

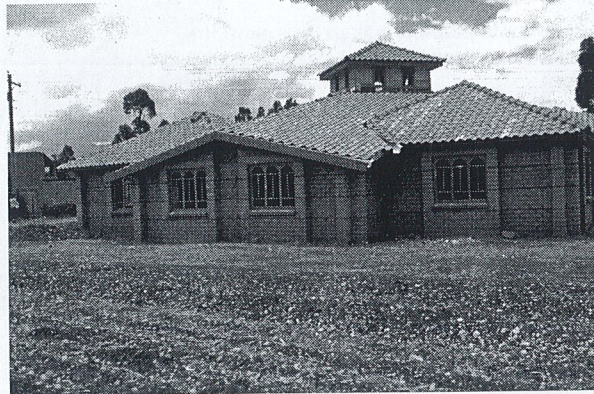
- Compressed Earth Blocks masonry.
- Vertical and horizontal steel reinforcements.
- Ring-beams in reinforced concrete.
- Independent light wooden tower

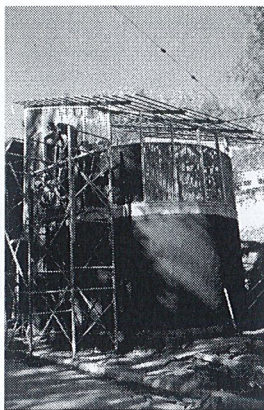
Ground floor
adobe and compressed
earth block masonry with
vertical and horizontal
reinforcements in bamboo

First floor
prefabricated wooden
pannels infilled with earth
(wattle and daub)

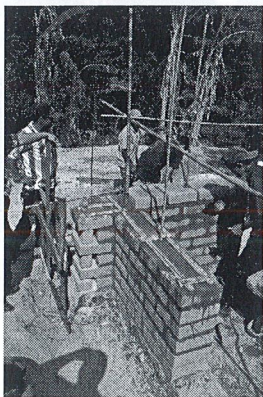
Light adobes (very rich
in straw)

Vertical and horizontal
reinforcements in caña
brava

Buttresses

Light roofing

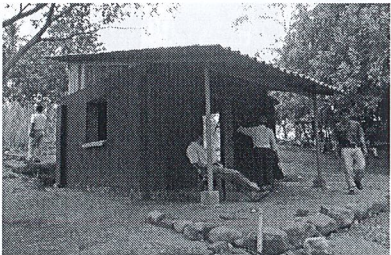
The prototype module built
during a training course
